TECHNICAL INSPECTION REPORT

366711
U.S.S. PENSACOLA (CCA24)

OPERATION CROSSROADS

PHOTOGRAPHS

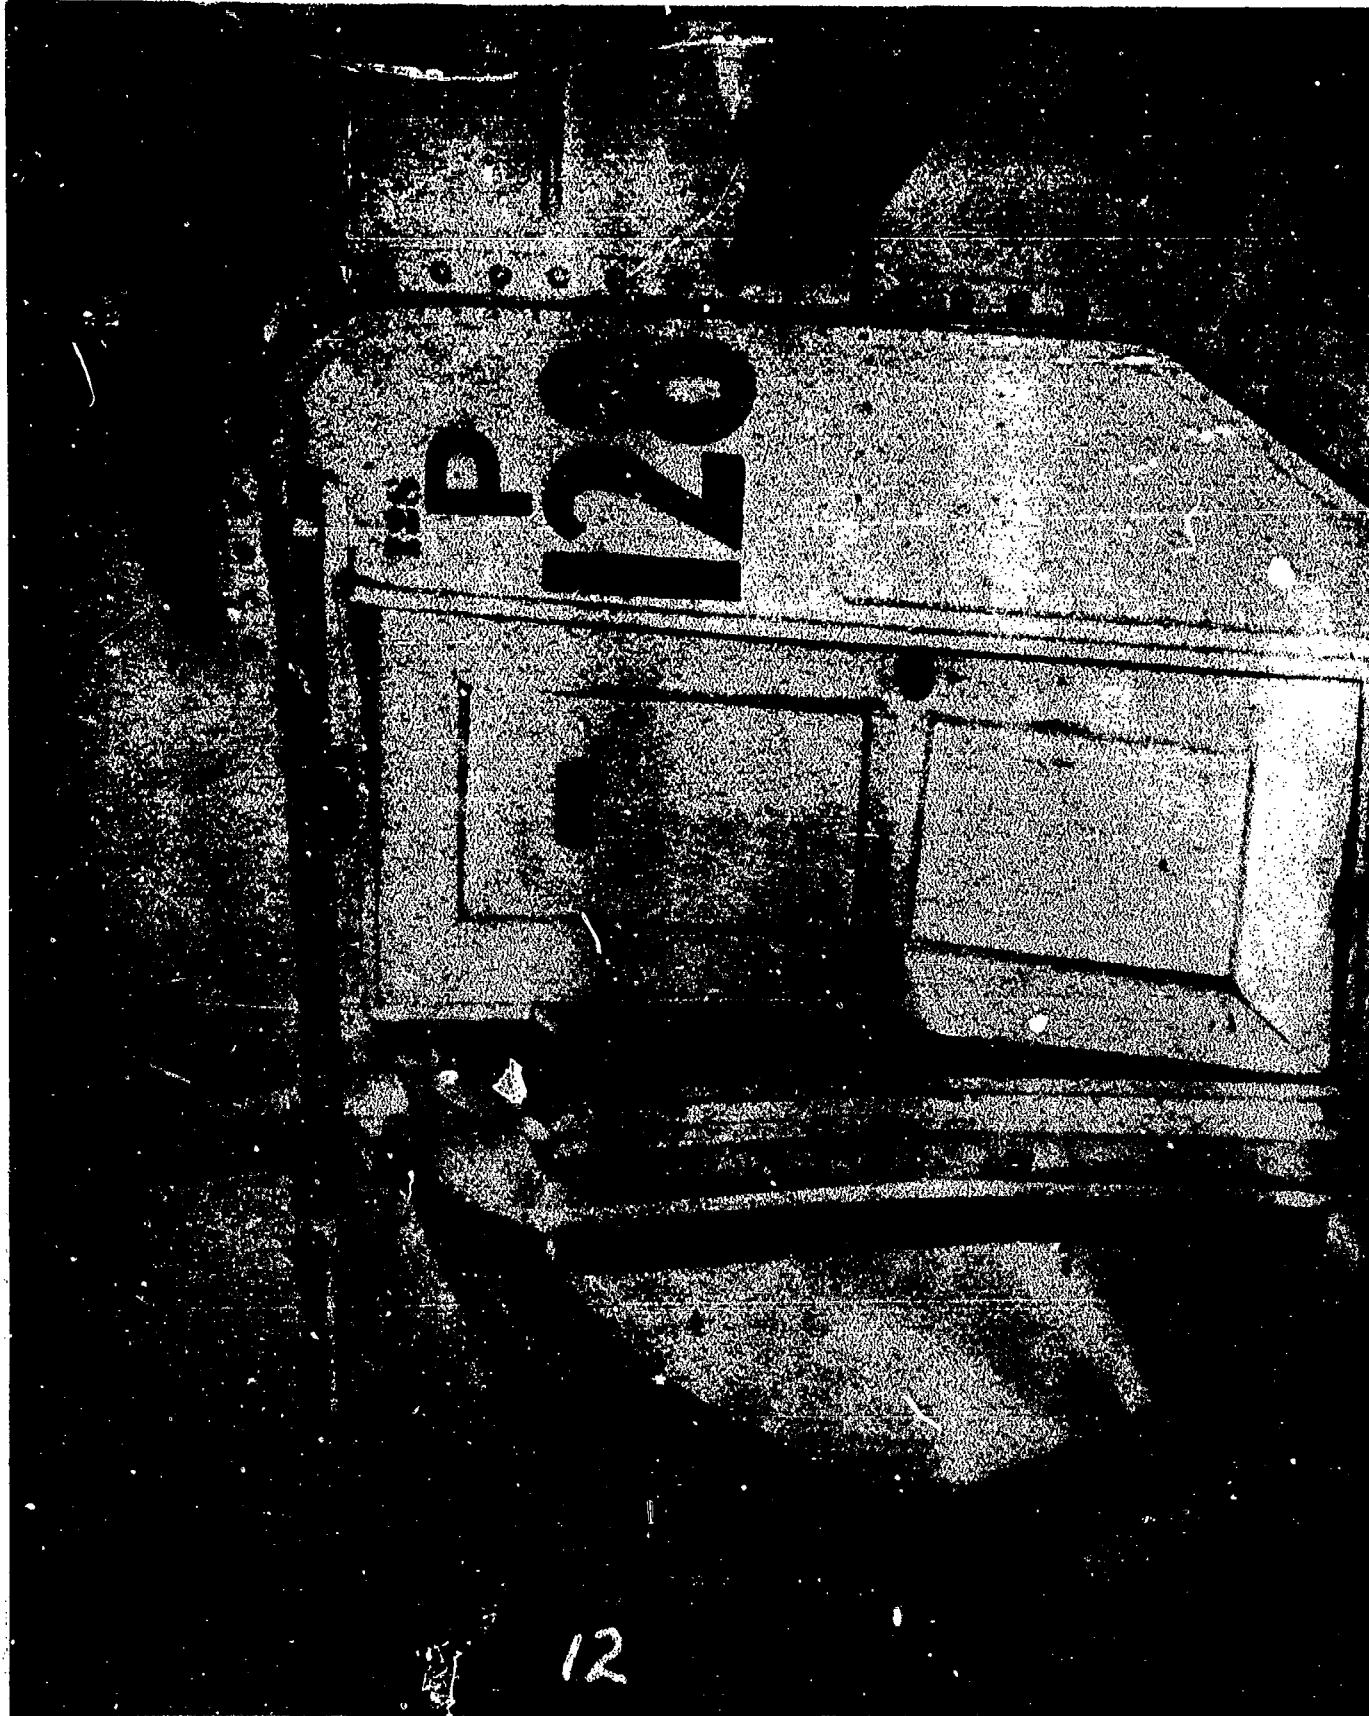
AA-CR-68-1765-12. Compartment D-203L, crew's space, 2nd deck, forward face of bulkhead 128 in way of port access.

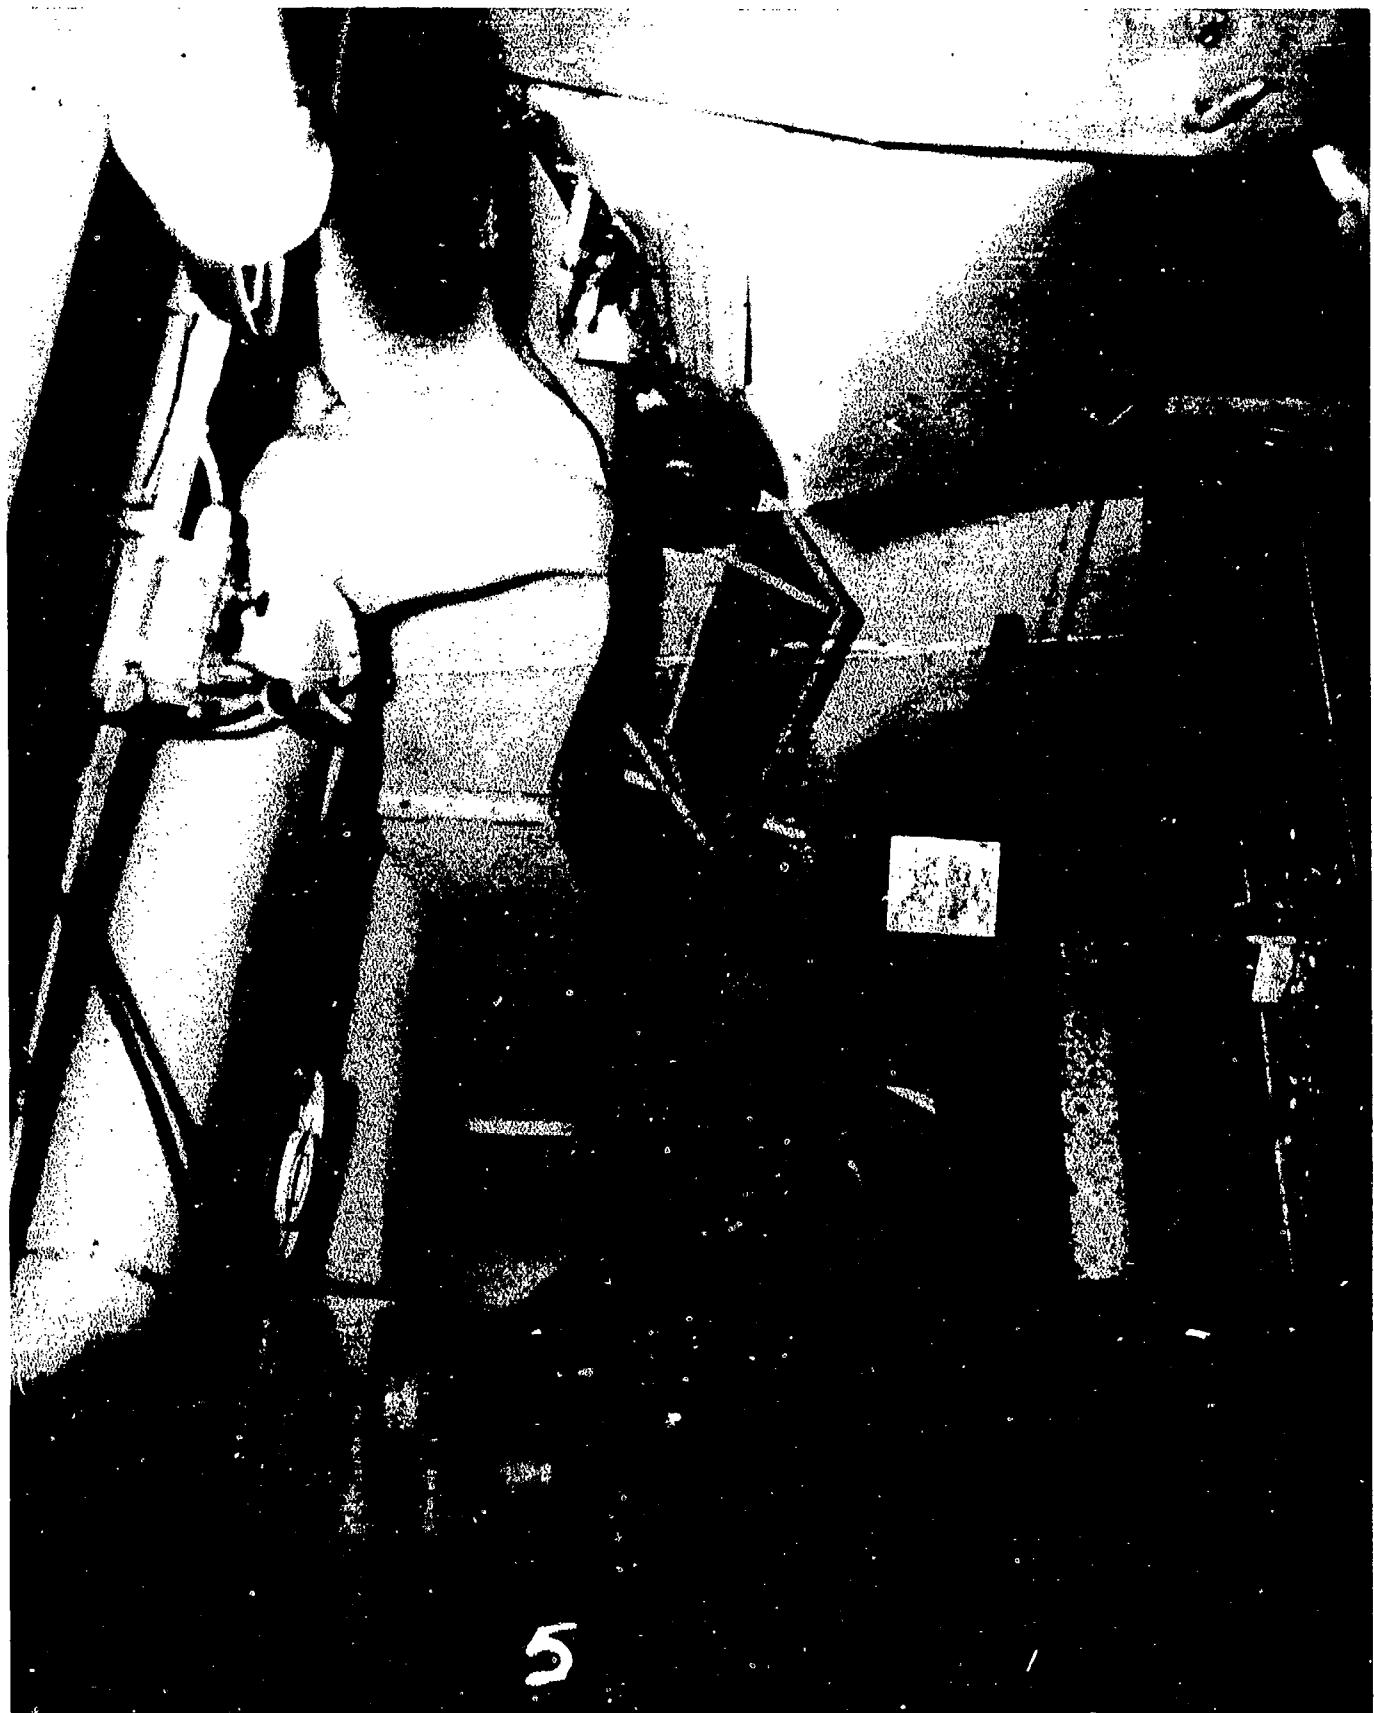
AA-CR-68-1755-5. Looking to port and forward to bulkhead 128 on 2nd deck.

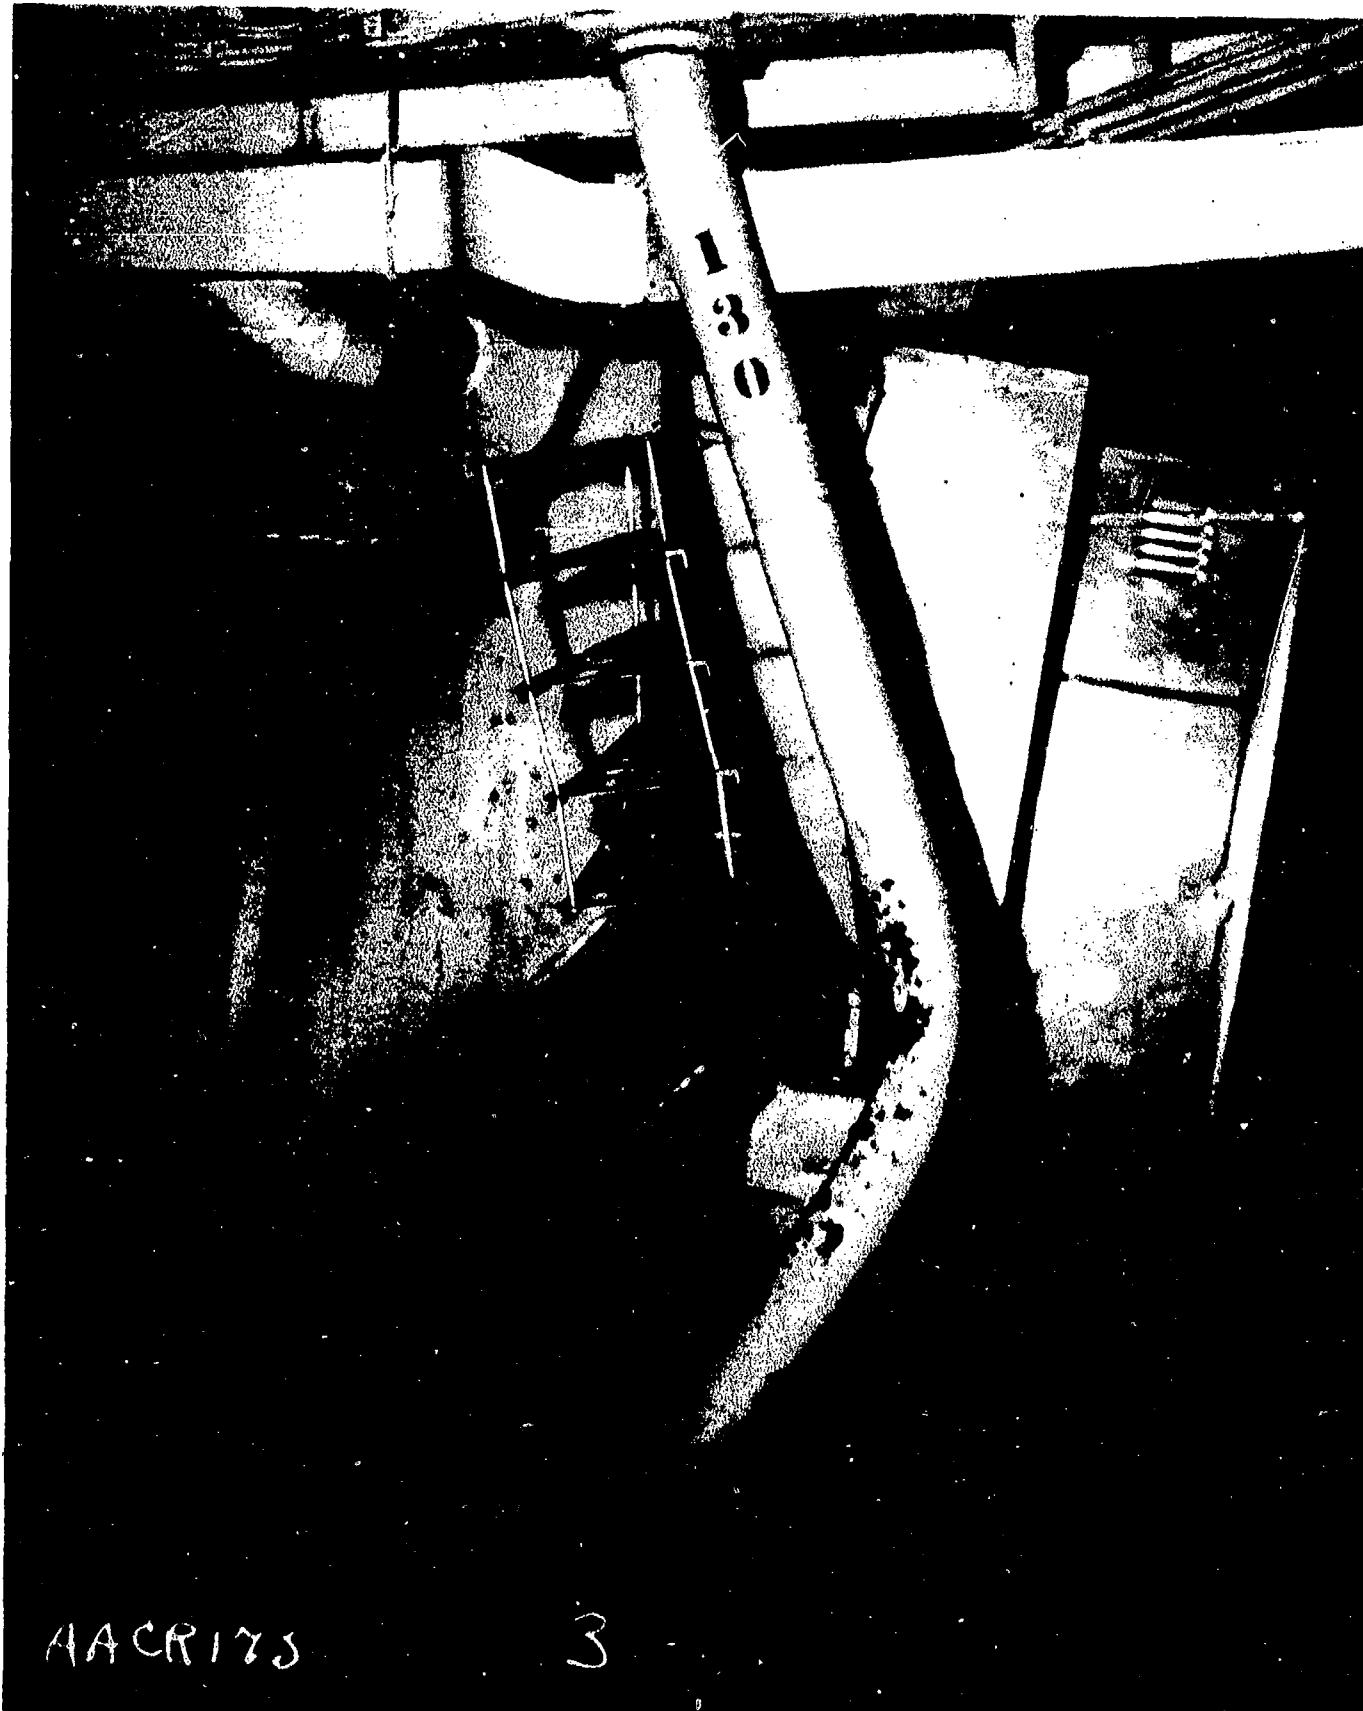
AA-CR-175-2179-3. D-203-2L. Looking aft on 2nd deck in C.P.O. mess showing damage to stanchion at frame 130, starboard.

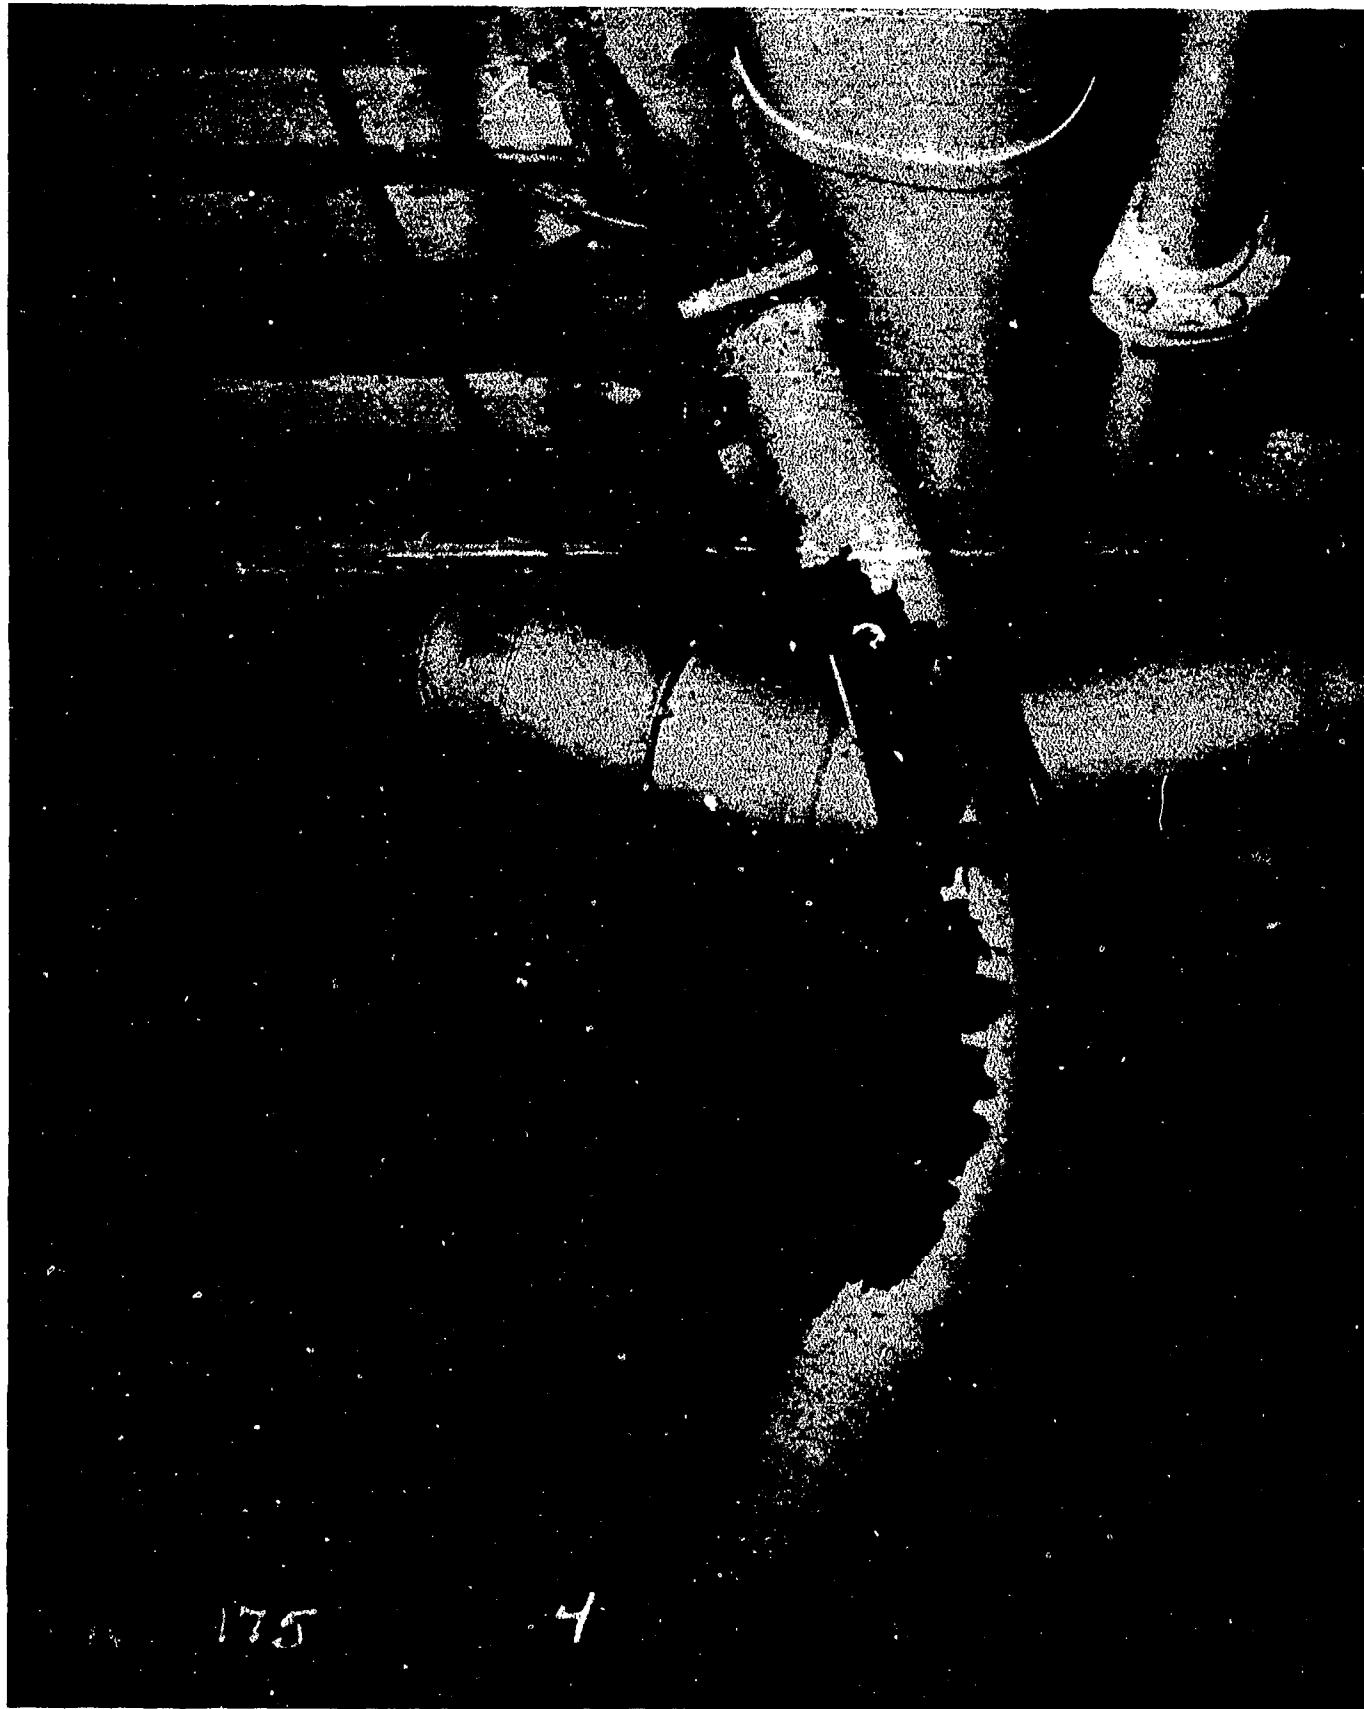
AA-CR-175-2179-4. D-203-2L. Looking aft at centerline stanchion and girder at frame 130.

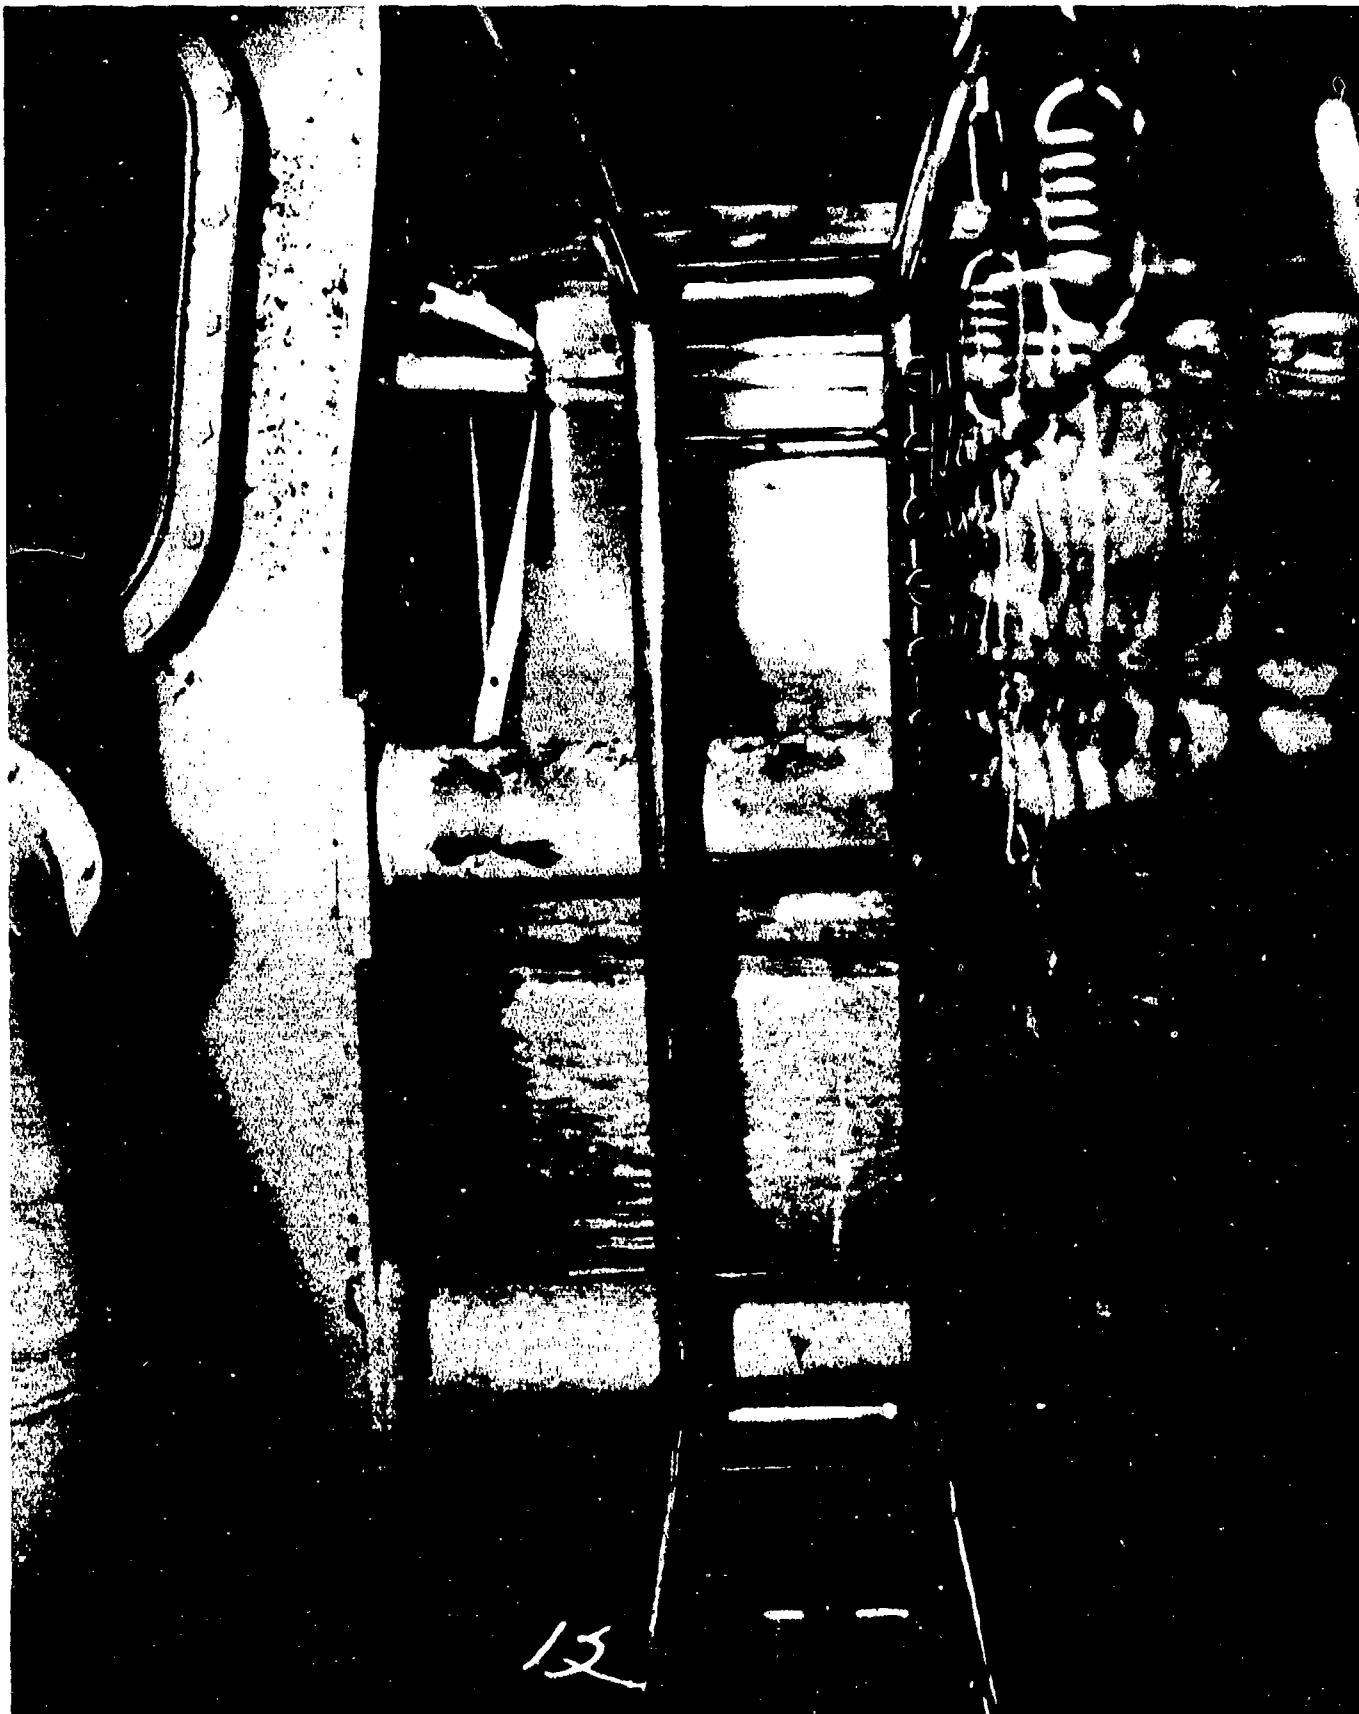
AA-CR-175-2179-12. Looking forward on 2nd deck showing failure of port side stanchion at frame 135. Note deflection of deck beam toward centerline.

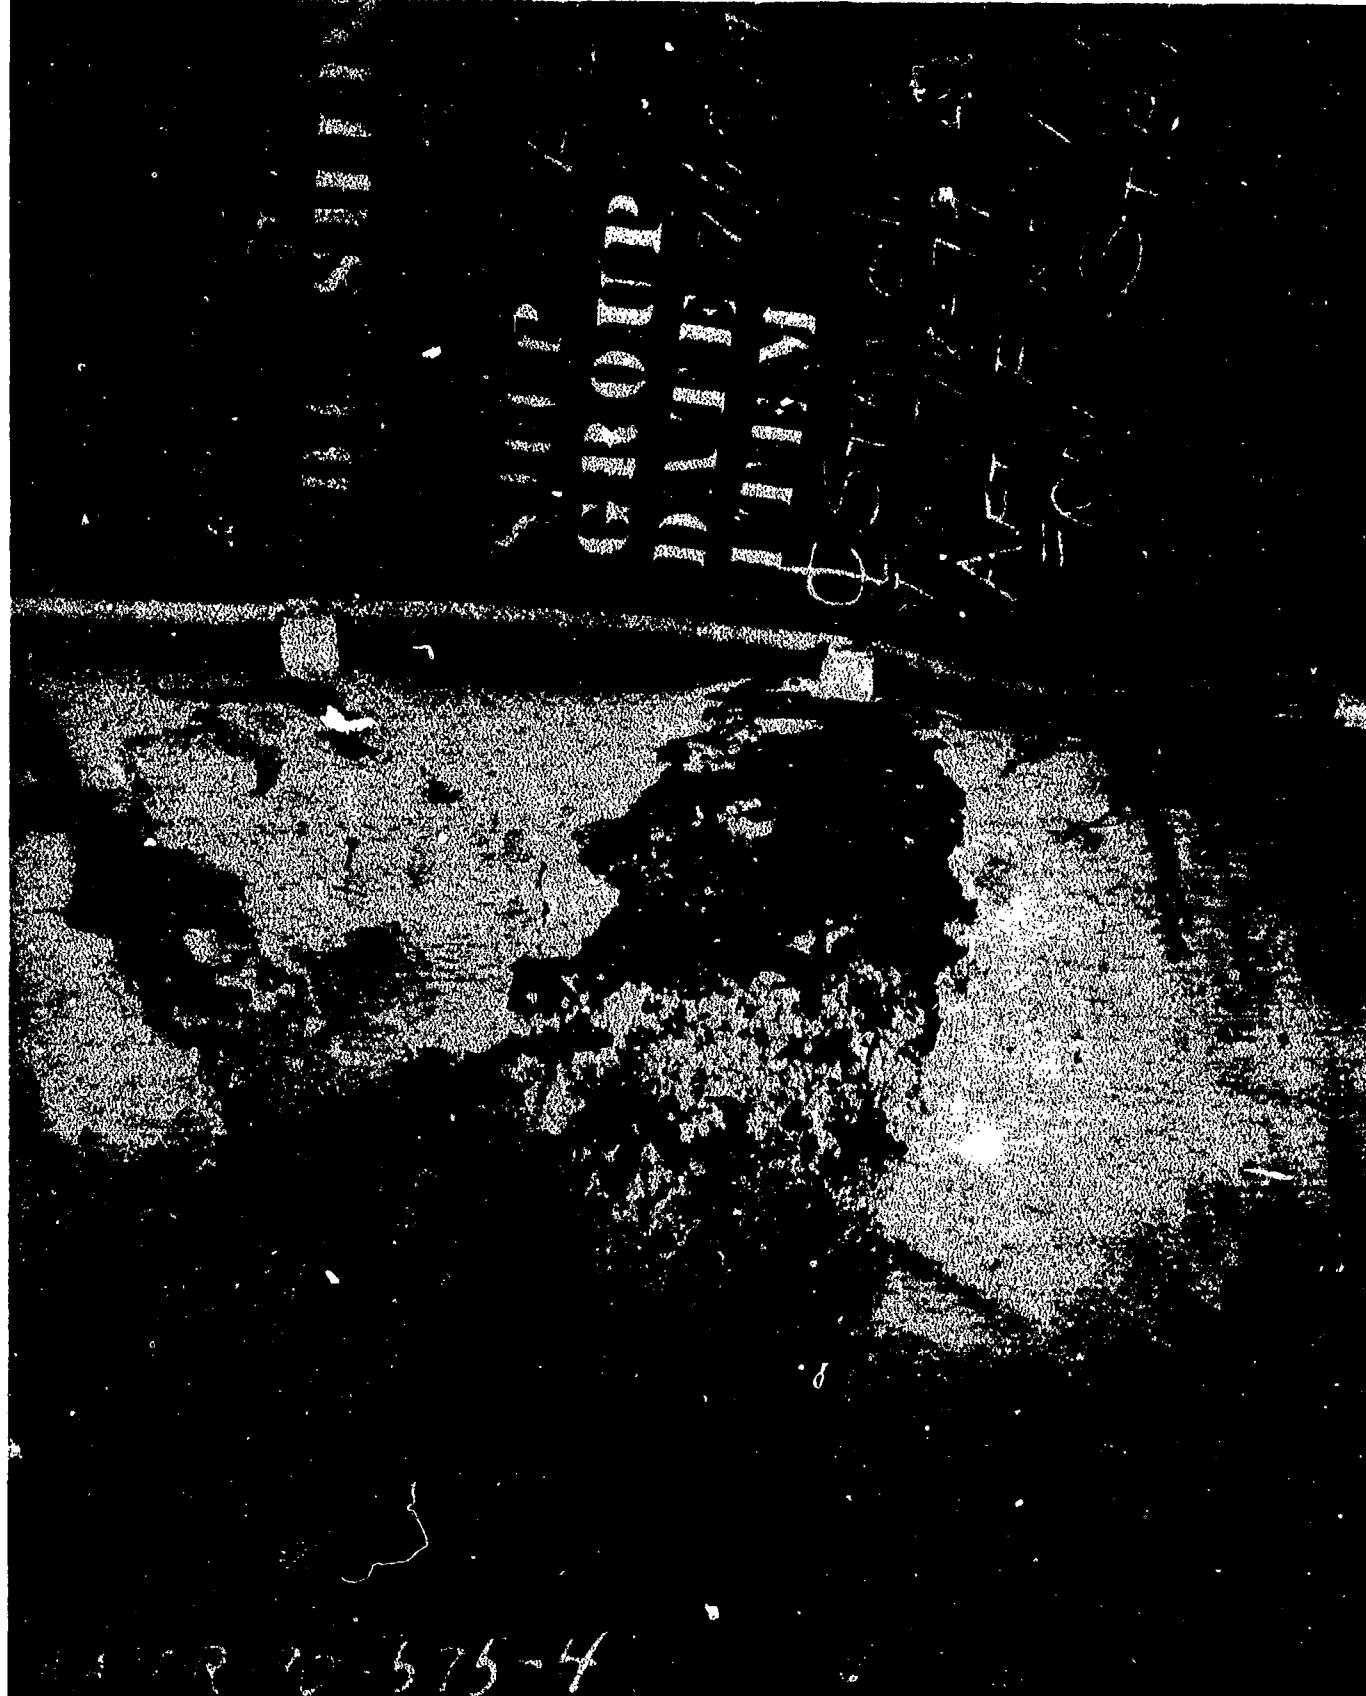
AA-CR-90-575-4. B-2. Close-up of stressed paint on centerline stanchion in after fireroom at frame 78 1/2.

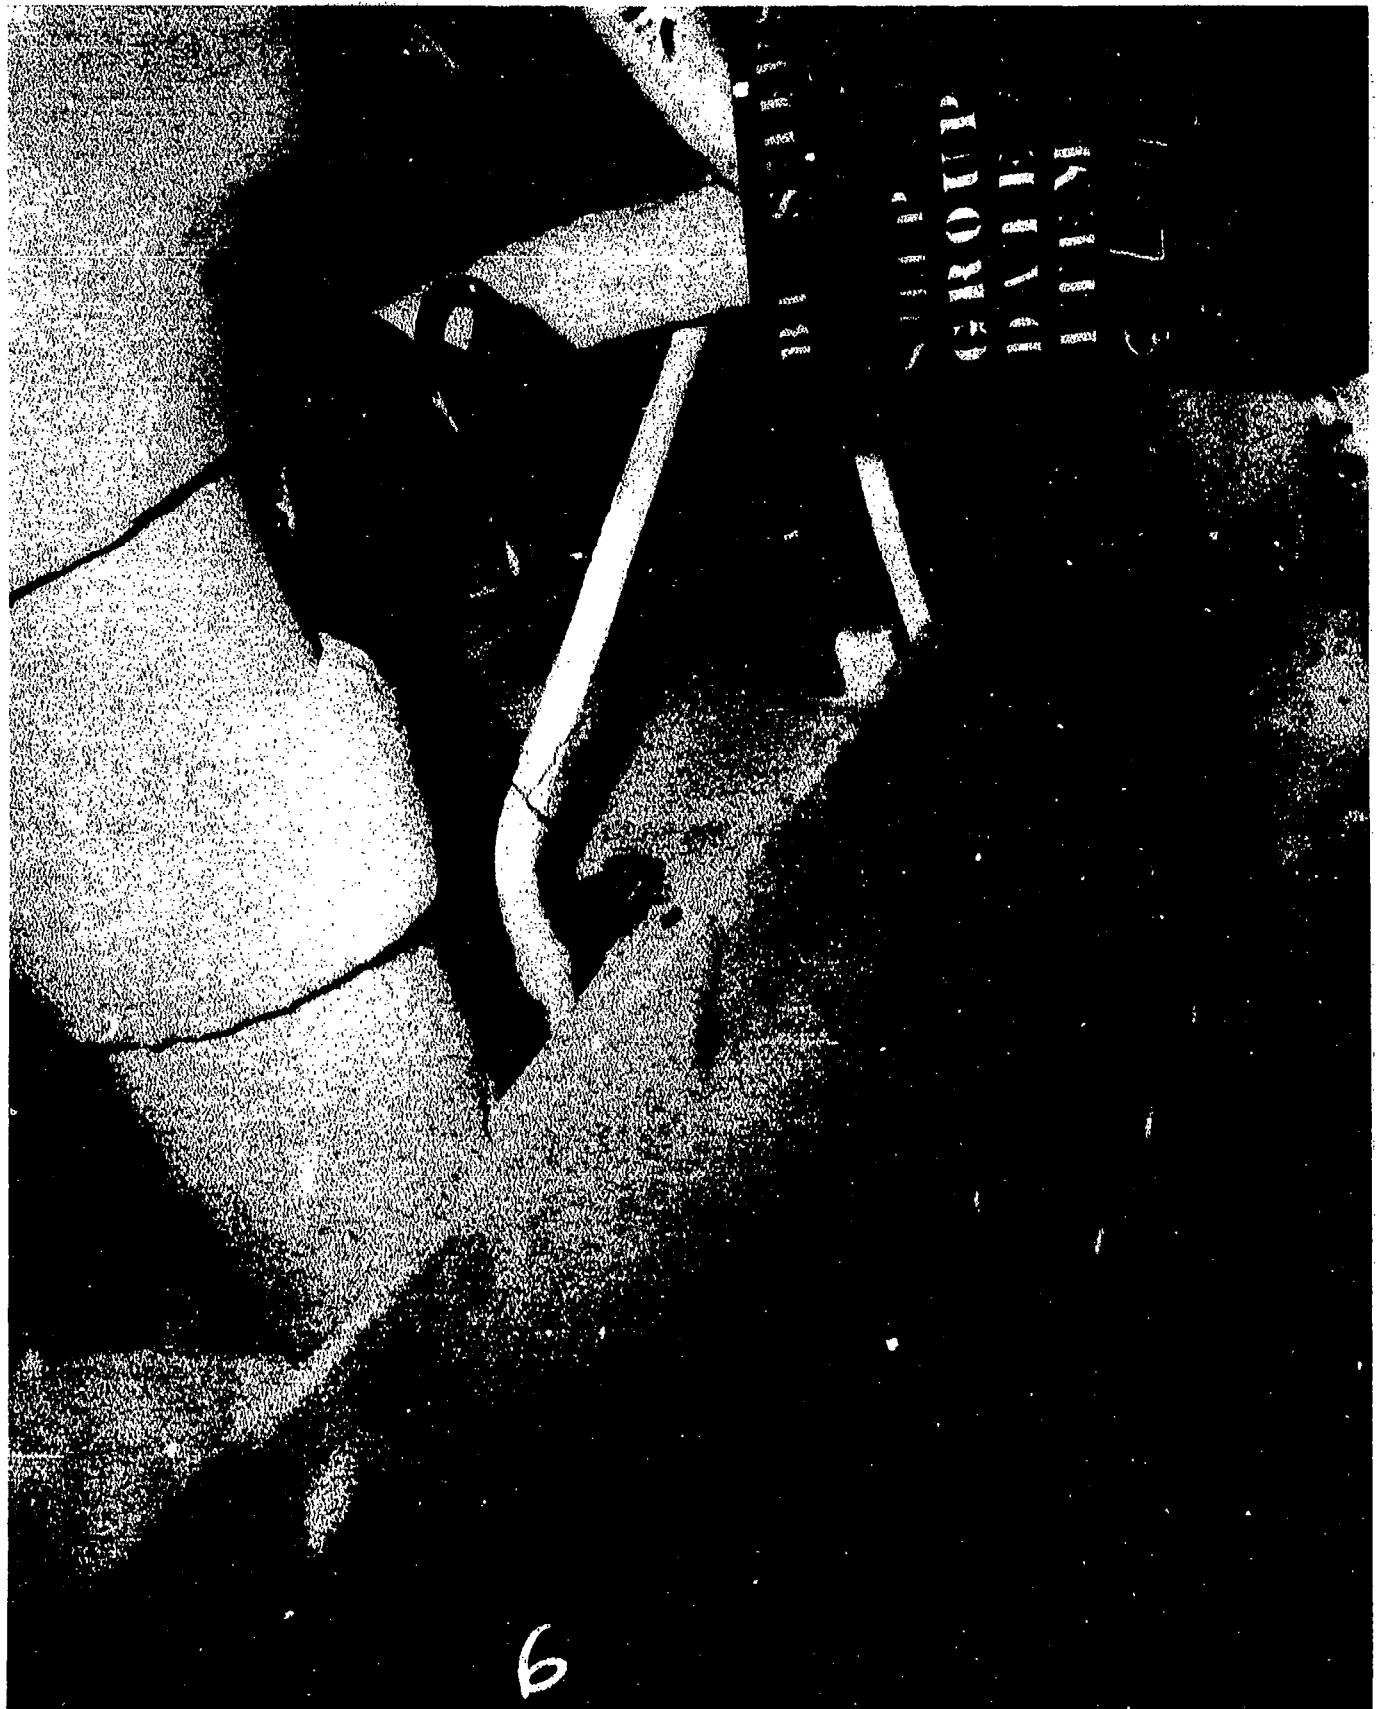
AA-CR-90-574-6. Looking aft in after engine room showing centerline girder, frames 95-96.

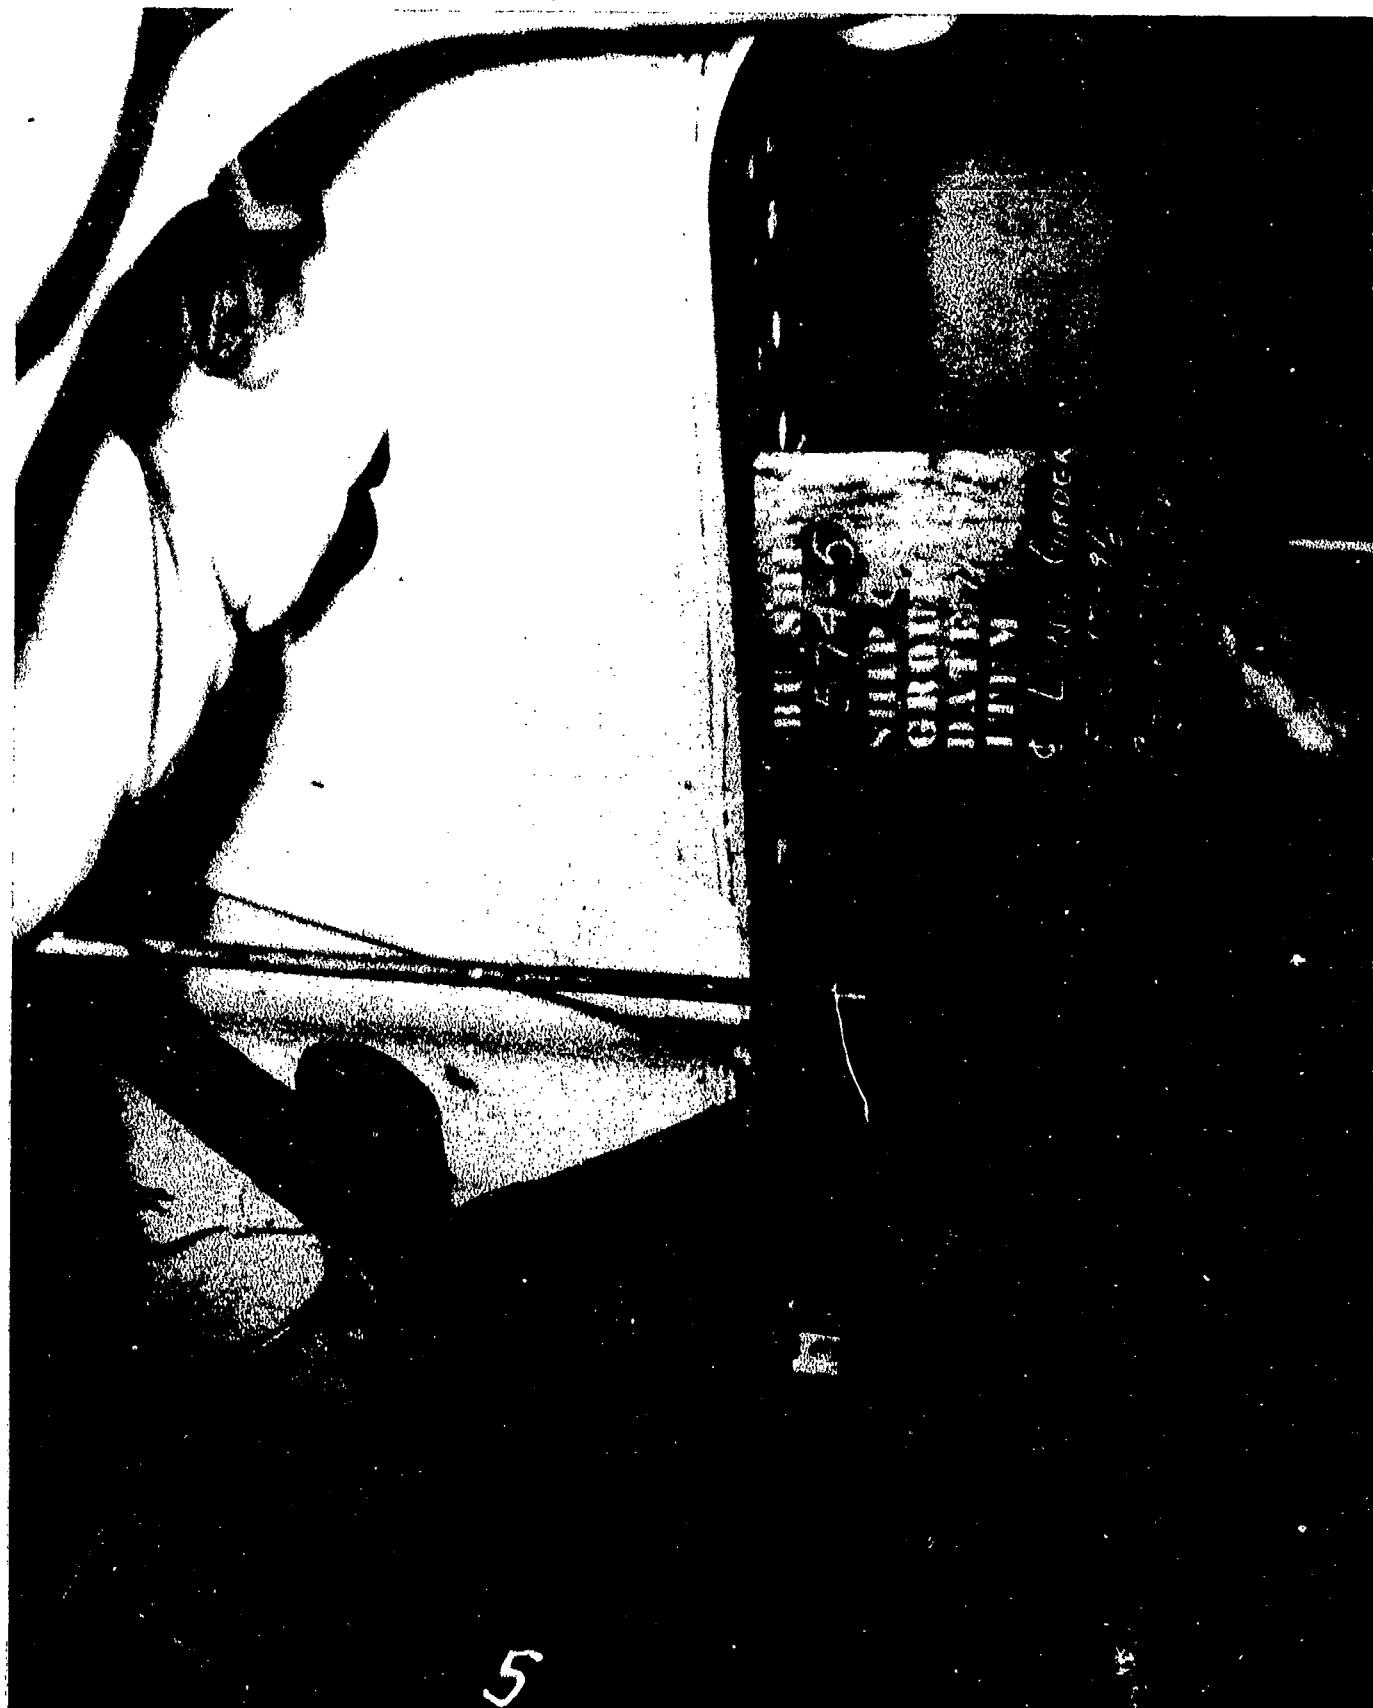
5

AA-CR-90-574-5. C-2. Looking to starboard in after engine room just forward of after bulkhead, showing centerline girder, frames 95-96.

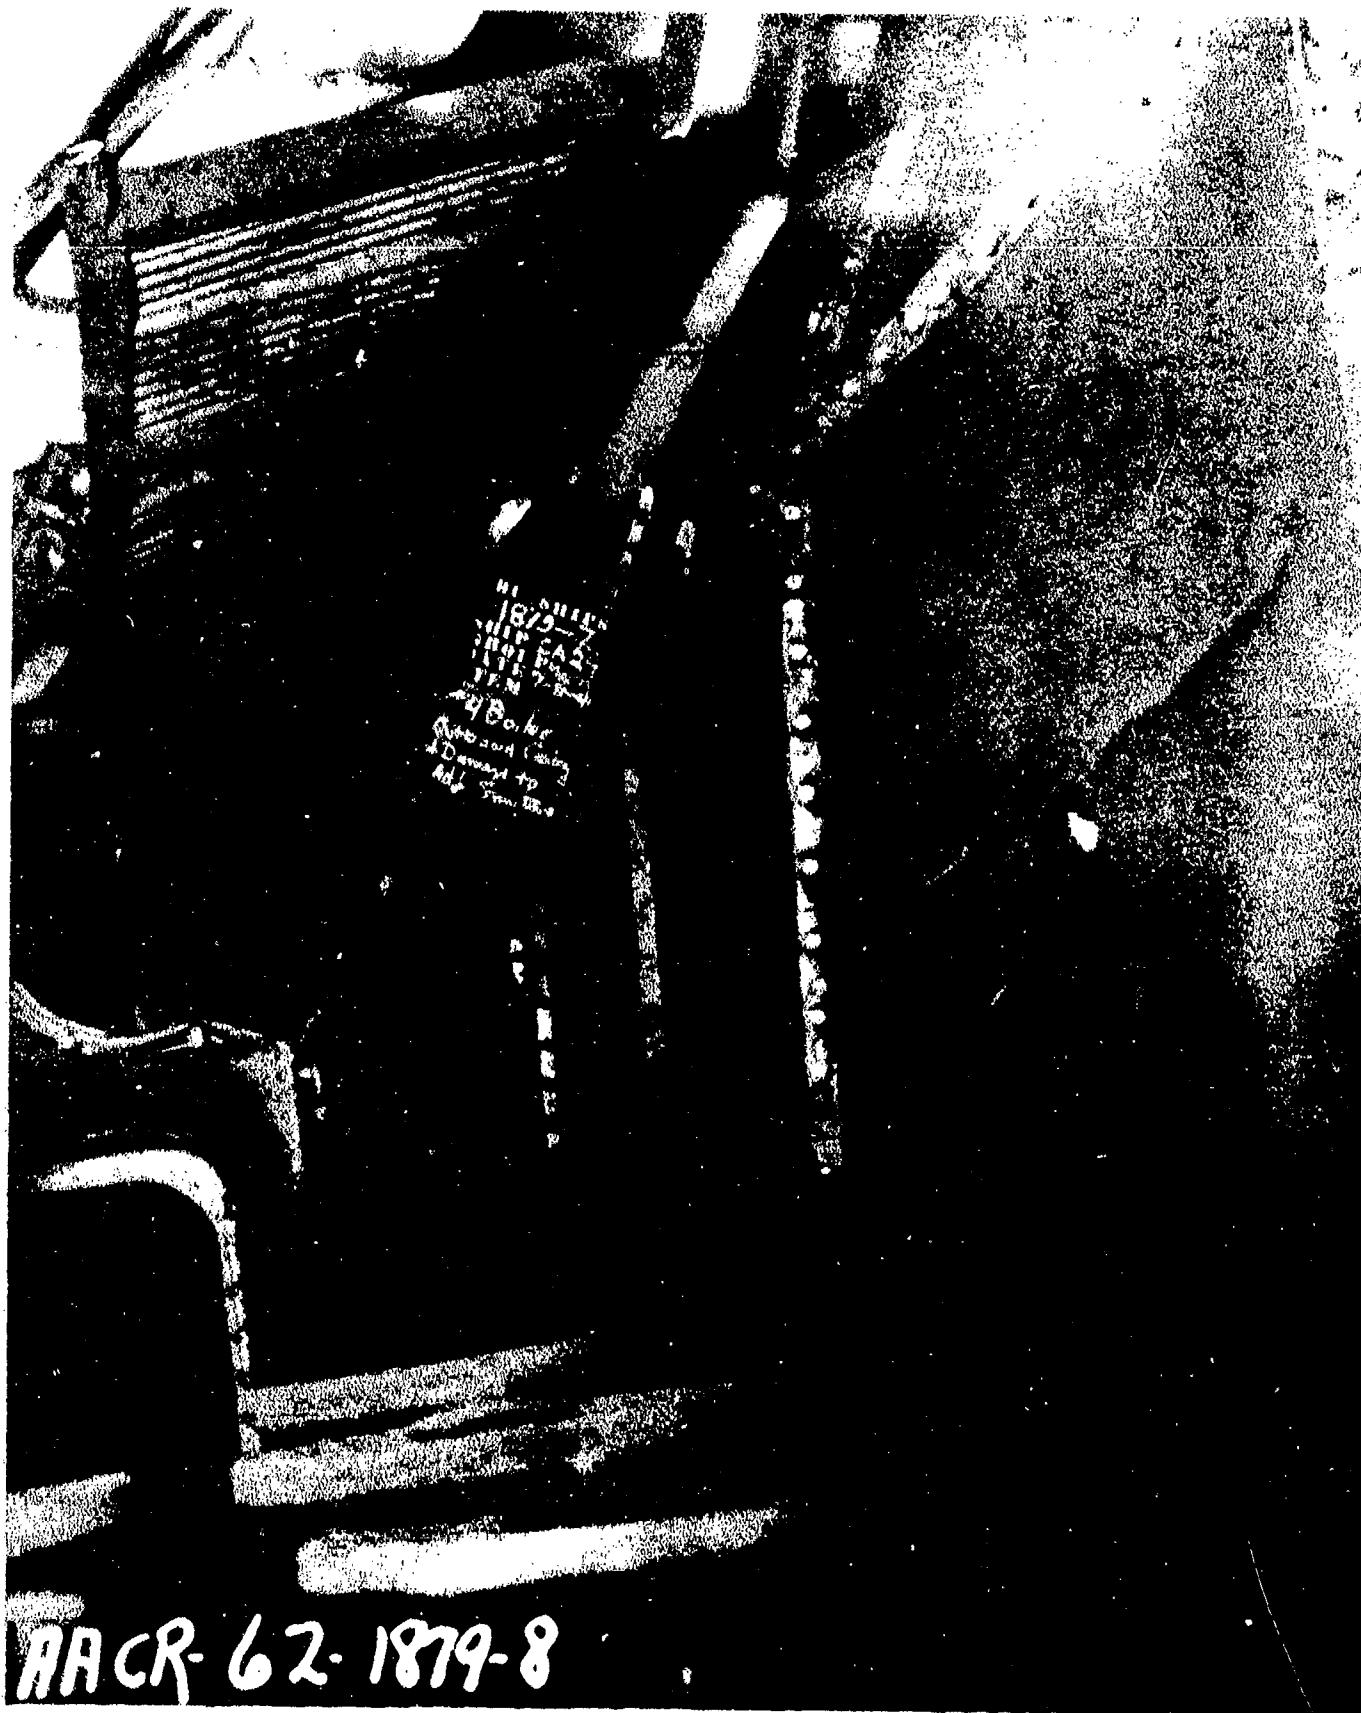
AA-CR-62-1879-8

AA-CR-62-1879-8. #4 Boiler, outboard casing.
